TO: MR. SHERIFF  
FROM: JIM DARDEN *JD*  
SUBJECT: MAXINE RECLAMATION

**RECLAMATION PLAN FOR PRE-LAW REFUSE DISPOSAL AREA  
OF MAXINE MINE AND IMPACTS ON WATER QUALITY**

**D.E. Pettry, Ph.D.**

**J. Darden, Manager Land  
& Forestry, ABC**

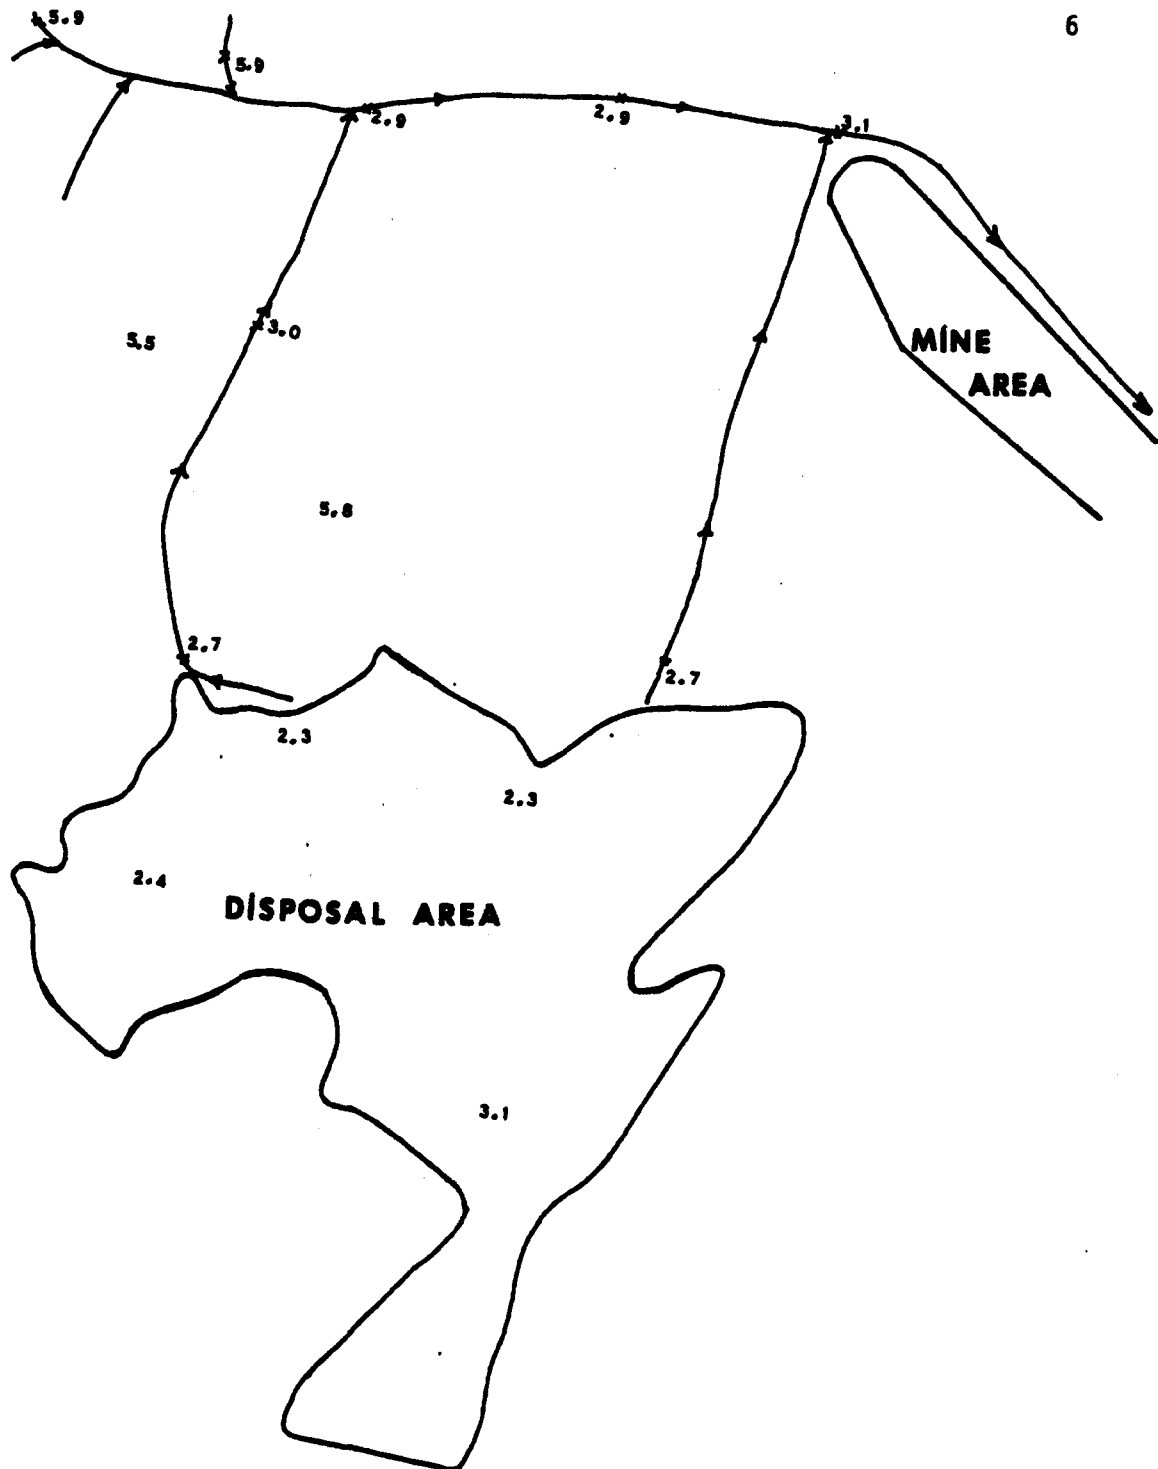
Figure 1. pH Levels of Spoil, Natural Wooded Areas and Drainage Waters Showing Detrimental Impact of Spoil to Water Quality.

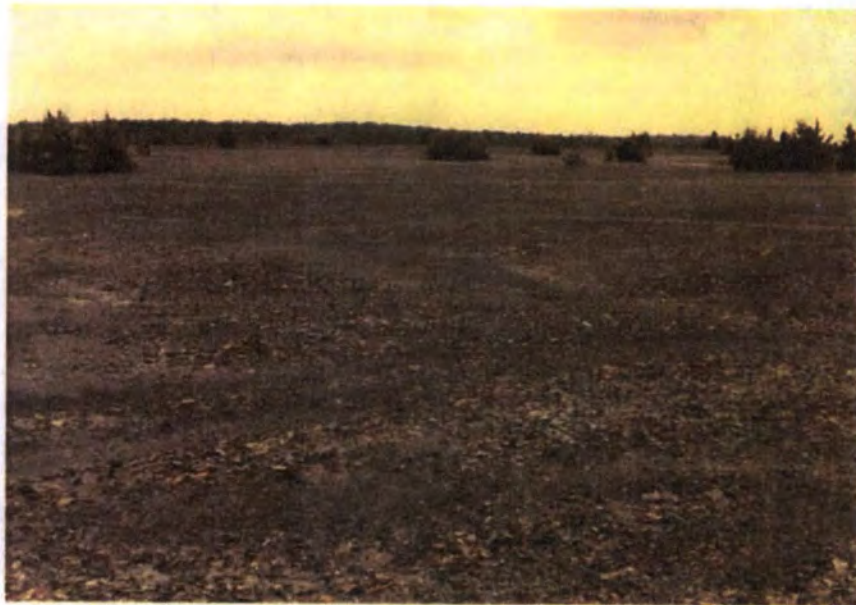
Photo 1. View of the Flatter Topographic Part of Refuse Area Showing Microrelief and Surface Flow Patterns. The Area Is Bare of Vegetation Except For Volunteer Pine Trees. Note Coarse Fragment Surface Pavement and Brighter Colored Weathered Coarse Fragments.

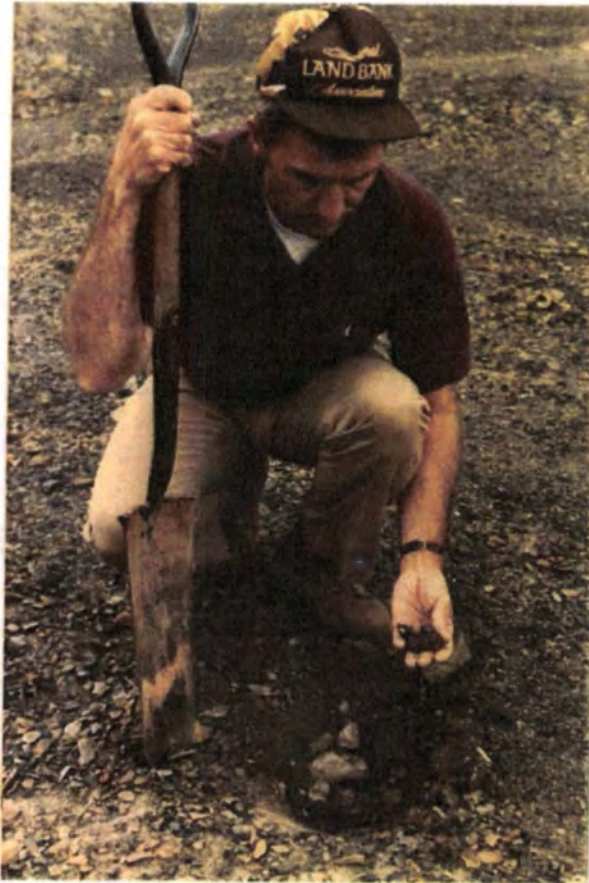
Photo 2. Shallow Excavation Into Spoil Showing the Mixture of Fines and Coarse Fragments. A Large Proportion of Coarse Fragments Are Less Than Two Inches Diameter.

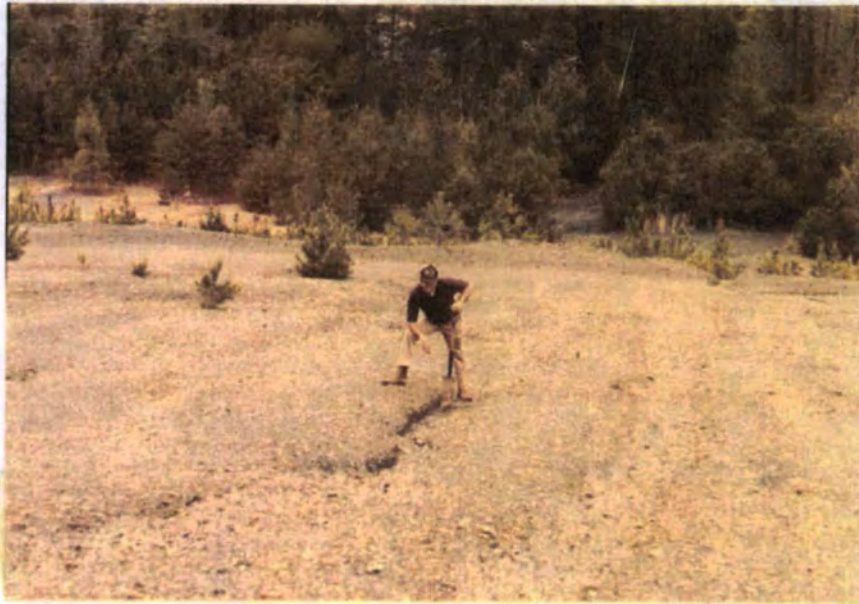
The refuse area is essentially bare of surface vegetation except for scattered small pine trees which have become established naturally (Photo 3). The bare surface presents an area greater than one million square feet for rainfall impact and resultant detachment and transport of acidic sediment from the site. Gullies are actively entrenching into the spoil and developing an extensive gulley system on the steeper, lower slopes towards the base of the fill (Photo 4). The gullies have eroded to depths of 7 feet and greater in places and the erosion will continue unless checked by stabilizing the site (Photos 5, 6).

**Photo 3. View of Middle Slope Position of Rock Disposal Area Showing Developing Gullies. Surface is Bare of Vegetation Except for Few Isolated Pine Trees That Have Invaded the Site Naturally. The Gulley System is Progressively Moving Upslope.**

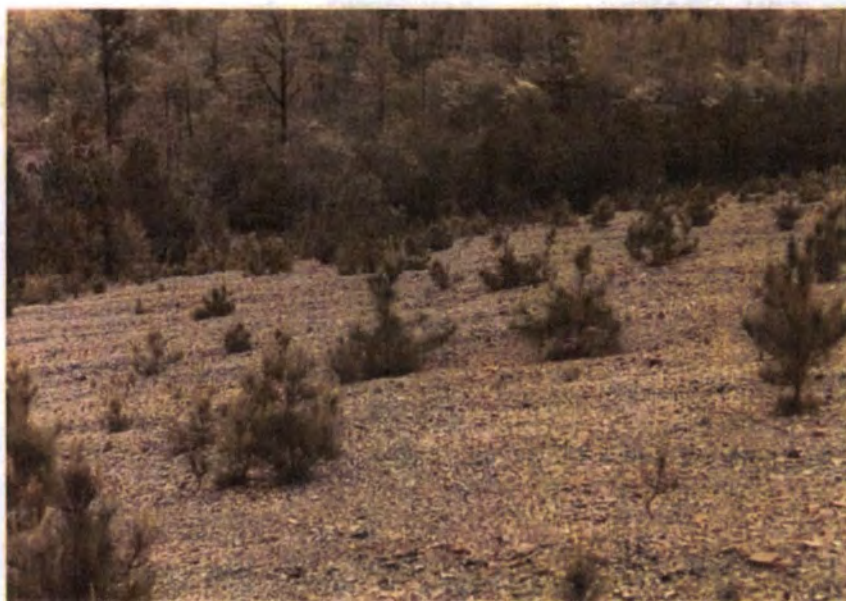
**Photo 4. Sideview of Midslope Position Showing Extensive Gulley Development Which is Progressively Eroding Deeper and Moving Upslope. Sediment from the Gullies Enters the Drainage System.**

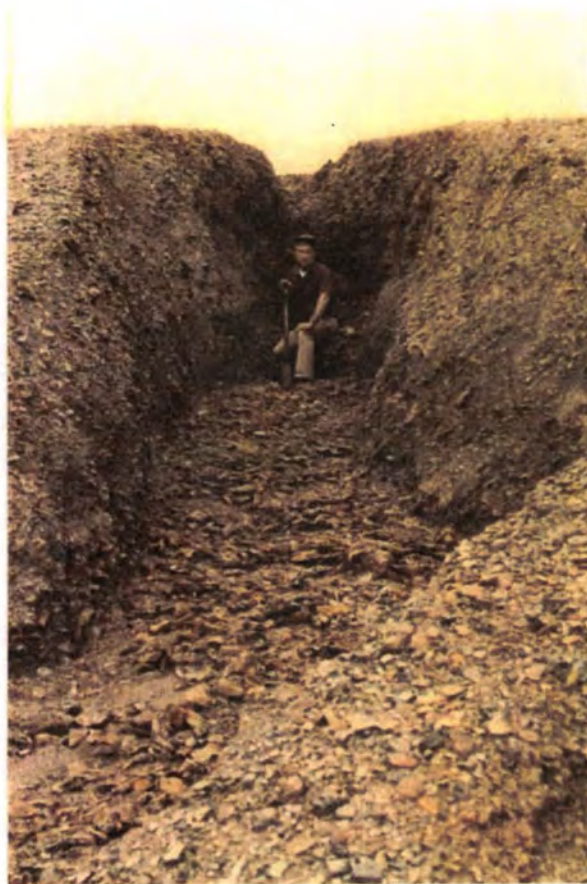
Photo 5. Large Gully on Lower Slope Position Which Has Eroded to Depths of 7 Feet. Note Uniformity of Material in the Banks of the Gully. Finer Particles Have Been detached and Transported as Sediment to the Drainage System.

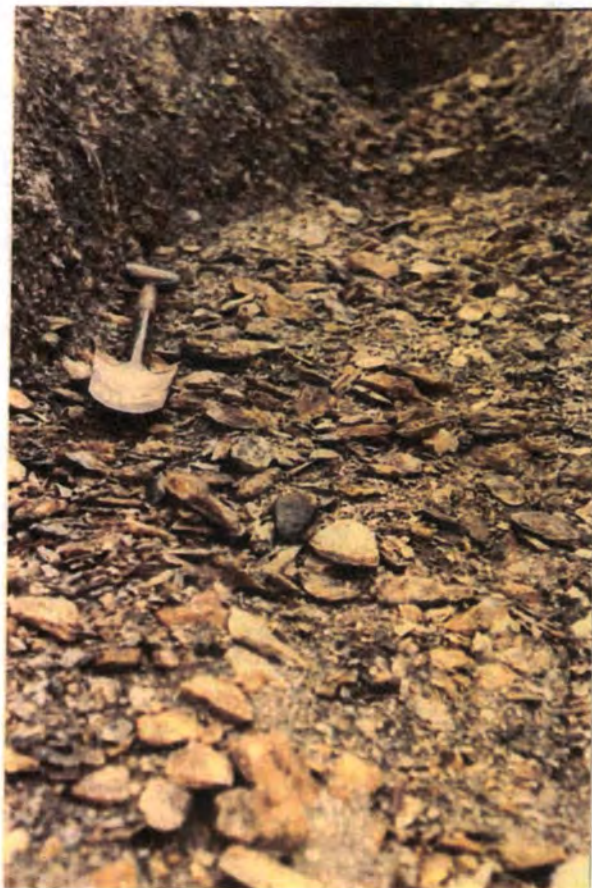
Photo 6. Close-up View of Gully on Lower Slope Showing the Concentration of Coarse Fragments Remaining After Finer Particles Have Eroded Away and Entered Drainage System. The Largest Coarse Fragments are About Seven Inches in Diameter. Note Iron and Sulfur Compounds Coating Rocks.

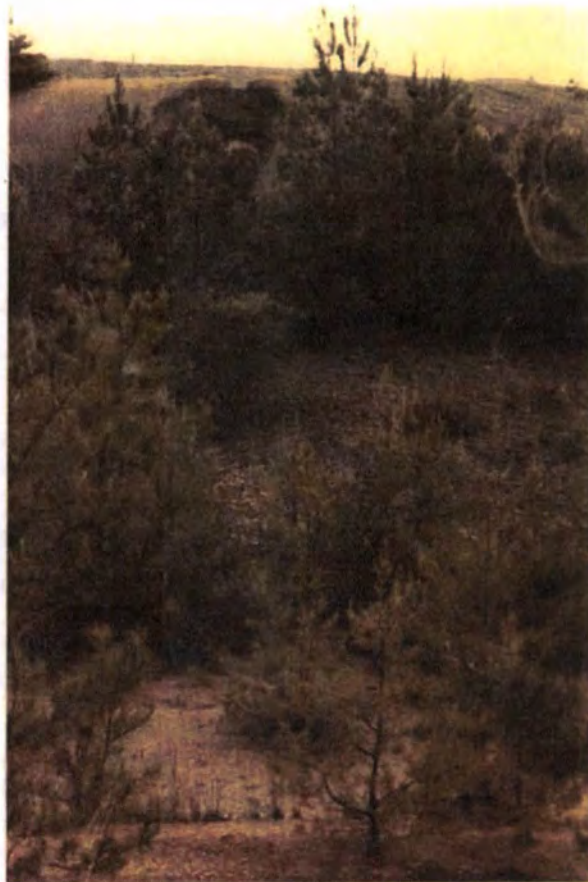
Photo 7. View of Bottom Edge of Rock Disposal Area Showing Large Gully. Inside of Gully Suggests Previous Combustion Activity. Note Thin Soil-Spoil Mixture and Pine Trees.

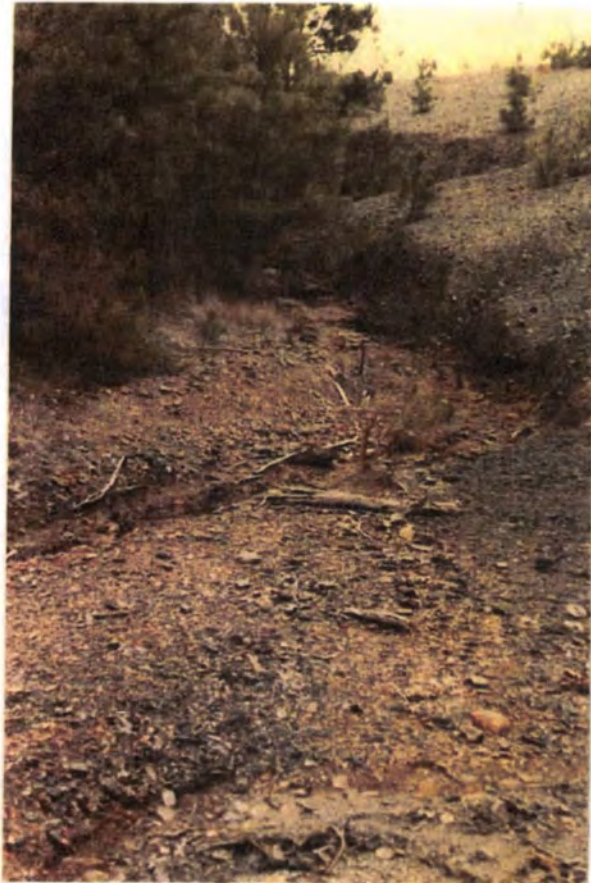
Although non-point seepage and emission from the spoil is evident in places, most of the discharge from the refuse area occurs along well-defined channels. As shown in Photo 8, a defined channel at the bottom of the spoil directs runoff and seepage from the site. Much of the channelized flow exits through the culvert shown in Photo 9 into the drainage of the natural wooded area. However, a large trash dump extends along the outer slope and lies in the path of the outflowing drainage (Photo 10). The trash is located directly in the path of the drainage waters from the culvert. The solid waste comprises a considerable volume and has a heterogeneous composition of metals, plastics, paper, chemicals and containers of unknown content (Photo 10). Contact of the exiting acidic waters with the trash may result in numerous compounds detrimental to

**Photo 8. Bottom Edge of Disposal Area Showing Gully Outlets and Drainage Channel that Collects Surface Runoff From Spoil and Seepage. Note Lining of Channel with Acidic Spoil Material and Iron Oxide Coatings.**

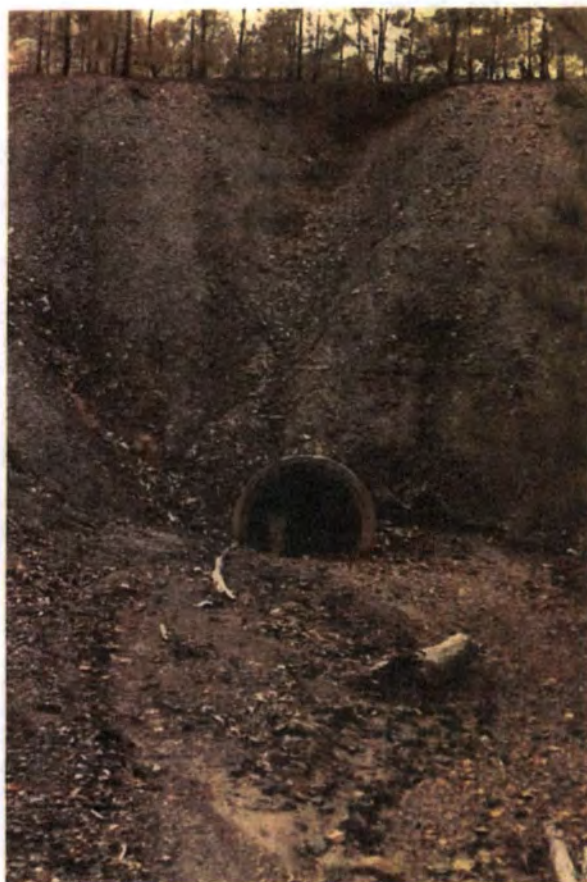
Much of the upper drainage system immediately below the spoil area contains acidic spoil as shown in Photo 9. This acid material serves as a constant source of acidification to

the drainage waters and source of sulfate, iron, and manganese. Fines from the spoil sediment (clay and silt) have tended to armour (coat) sandstone and shale coarse fragments which then serve as a constant source of acid in the drainage waters. Immediately below the drainage culvert in Photo 9, the channel bottom is coated with red iron oxides for some distance where the iron enriched leachate waters have reacted with oxygen and precipitated the iron to an insoluble form. It appears that the red iron oxide coating forms during periods of reduced flow, and the material is periodically purged during peak flows when the water contains a high sediment load.

Photo 9. Drainage Channel Immediately Downslope From Disposal Area Showing Culvert Passing Under Road Constructed of Old Spoil and "Red Dog." Note Accumulation of Acidic Spoil on Bottom of Channel Which Will Move Downslope Into Drainage System. Much of the Surface Flow from the Disposal Area Exits Through This Culvert.

It is recommended that the acid sediment deposited upstream of the culvert be removed by backhoe or front-end loader and a neutralization interception system be constructed of  $\text{Ca}(\text{OH})_2$ , lime, and limestone. A similar intercept should be prepared at the other main outflow. It is further suggested that the drain at the bottom of the spoil as shown in Photo 8 be lined with limestone coarse fragments to reduce flow velocity and neutralize acidity.

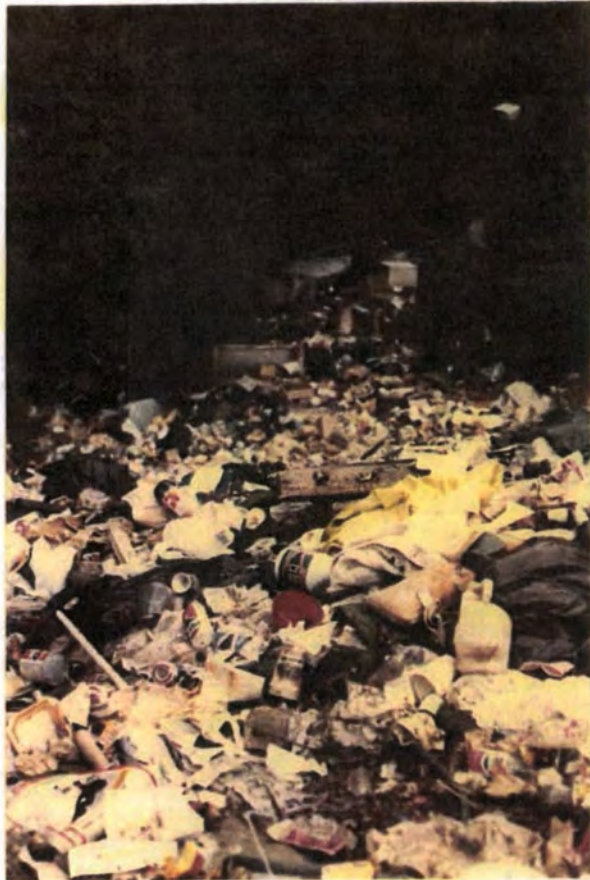
water quality, including iron and other metallic reaction products and possibly chlorinated hydrocarbons. The trash represents a concentrated reservoir of metallic components for entry into the drainage water and subsequent degradation of water quality. Trash was being deposited at the dump as recently as April, 1985, apparently from residences in the vicinity.

Photo 10. Trash Dump Located Directly in the Path of Water Draining the Disposal Area. Trash Covers Downslope Exit of Culvert. Note Diversity of the Trash Which Serves to Add to Degradation of Stream Quality. Channel Exiting Bottom of Dump is Coated with Red Iron Oxide.

Prompt corrective actions to the immediate drainage system emitting from the pre-law spoil area are deemed prudent. It is recommended that the trash dump in the interception area of exiting waters be closed immediately to further dumping. The trash located in the drainage way should be removed, and the area should be treated with  $\text{Ca}(\text{OH})_2$ . Trash located above the direct contact area with drainage waters should be treated with  $\text{Ca}(\text{OH})_2$ , covered with at least 12-18 inches of topsoil and vegetated. It may be as economical and feasible to haul all the refuse off the site to a proper landfill for disposal rather than plate it.

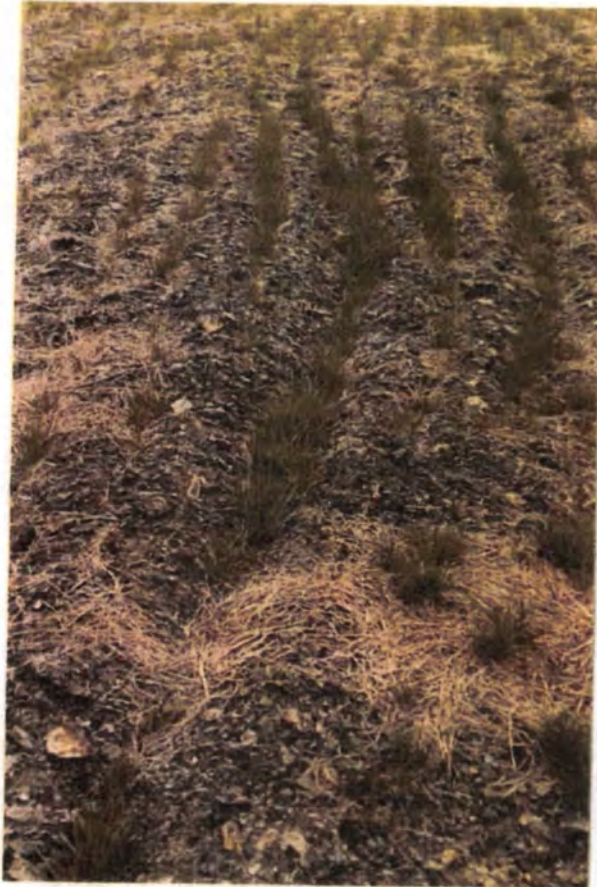
When the reclamation program was installed during the late summer and fall of 1984 at the lower Maxine area (washer plant area) a very small plot was prepared in the pre-law area for evaluation purposes by ABC personnel. Preparation of the area and application of amendments and seeding methods only approximated the reclamation efforts at the bottom site. Evaluations of the plot in April, 1985 indicated a partial stand of fescue had survived the winter and was growing (Photo 11). The surviving fescue was growing in depressed rills created by discing and little was noted between rills. The pH levels in the plot were very erratic and ranged from 3.2 to 6.5 indicating irregular distribution and incorporation of  $\text{Ca}(\text{OH})_2$  and lime. The lime and plant nutrients had tended to accumulate in the rills with finer particles of spoil. Moisture conditions were also more

Photo 11. View of Small Plot Located on Disposal Material Showing Fescue Growth in April, 1985. Note Concentration of Grass in the Rills. The Area Was Planted in Early Fall 1984 in Partially Amelioriated Material.

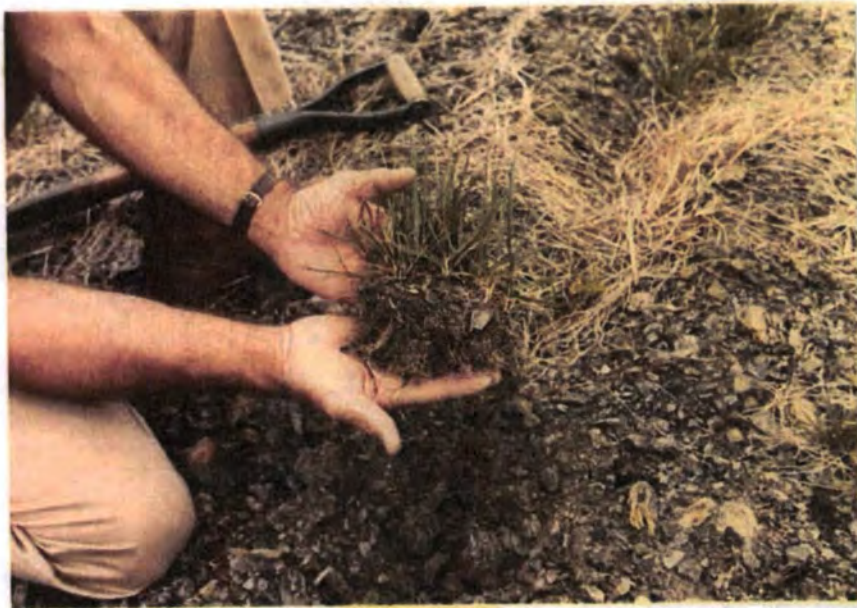
favorable in the rills. The fescue had a good root system as shown in Photo 12, with roots penetrating the spoil to the depth of  $\text{Ca}(\text{OH})_2$  treatment. The grass exhibited no toxicity symptoms and was actively growing. The roots of the fescue stabilized the spoil where they were growing. The germination, winter-survival and growth characteristics of the fescue grass in the partially treated spoil attests to the feasibility of direct vegetative establishment in the material. Pot tests with the spoil material indicate vegetation can be grown when it is properly beneficiated. The establishment and survival of pine trees by natural invasion of the spoil area also reflects the potential suitability of the material.

Photo 12. Close-up View of Fescue Clump in Experimental Plot in Spoil. The Fibrous Root System Had Developed to Depth of  $\text{Ca}(\text{OH})_2$  Incorporation. Note Stabilization of Spoil Material by Fibrous Root System Which Would Prevent Erosion.
